HEALTH & SAFETY *BULLETIN*

Source Testing Association

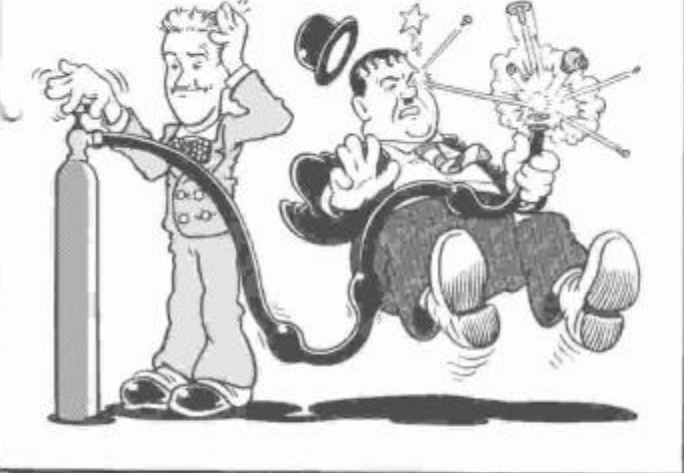
Always wear suitable eye and face protection when dealing with gas.

Did you know?
A high pressure jet of gas can pierce the eyeball.

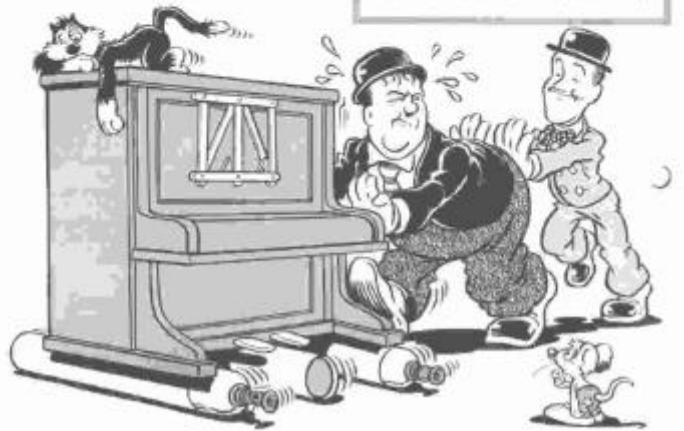
The right way

Never use cylinders as rollers.
